Inspection Report

310 Windy Hills Drive
Columbus, SC

HomeBuyers Inspection HBI

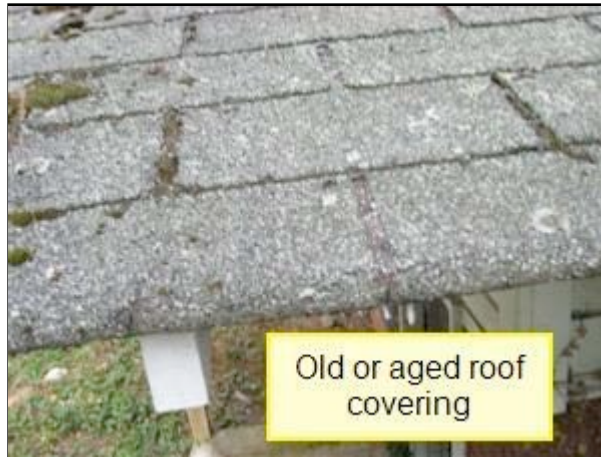
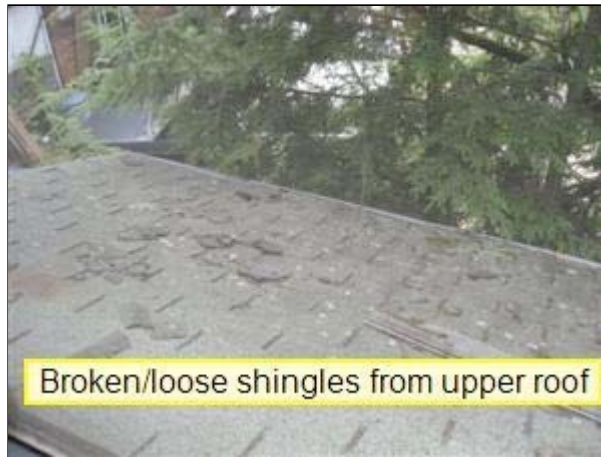
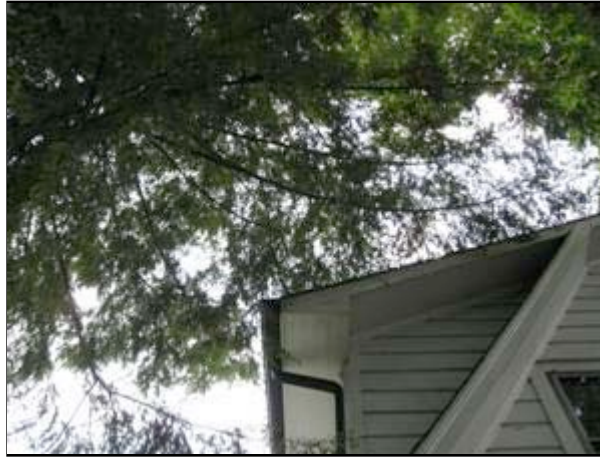
1.0 Picture 1

(1) The roof covering is old, and the life of covering has expired. The covering does need to be replaced. While it could last a year or so, some areas may need patching with tar as leaks develop. Some shingles are missing on main roof and daylight can be seen from attic. Immediate repairs are needed here.

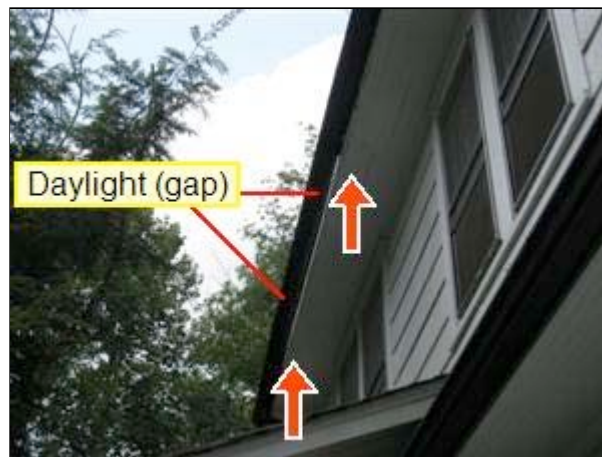
1.3 Picture 1

(1) The gutter is loose or daylight between gutters and fascia at the rear. Loose or leaking gutters can cause deterioration of fascia, soffit or roof edge. It can also cause gutters to pull loose and lead to possible water intrusion. A qualified contractor should inspect and repair as needed.

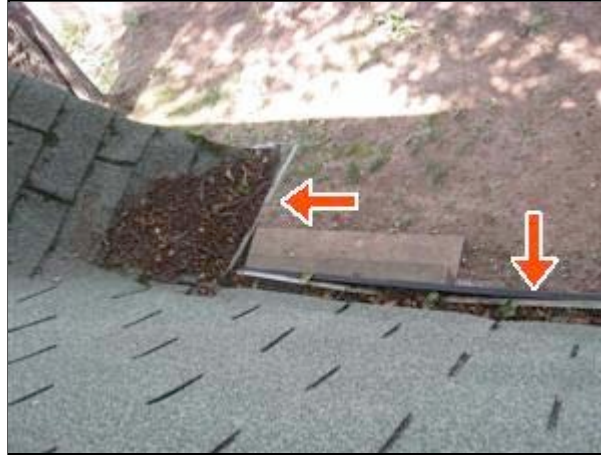
1.3 Picture 2

should repair or replace as needed. The gutter needs cleaning of debris at the front and as needed elsewhere. Gutters that drain poorly or clogged can lead to many costly problems such as deterioration of fascia, soffit or roof edge. It can also cause gutters to pull loose and lead to possible water intrusion. A qualified person should repair or replace as needed.

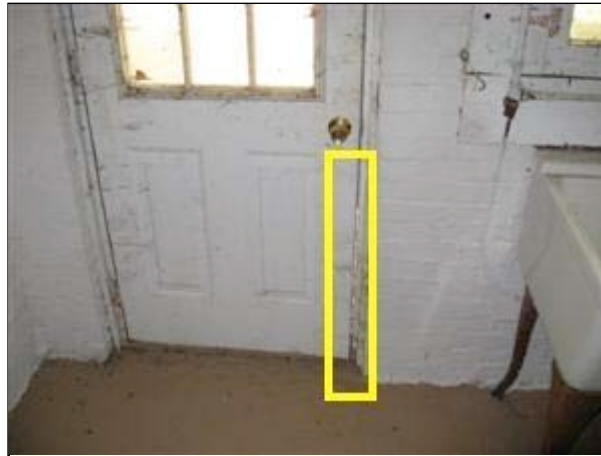
2.1 Picture 1 Basement entry

The side entry door to basement reveals daylight when latched at areas missing weather-stripping. This is a small repair. A qualified person should repair or replace as needed.

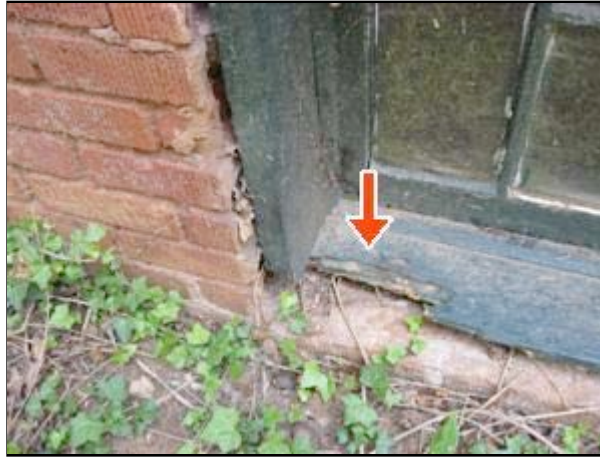
2.2 Picture 1 Basement window (s)

The sill plate is deteriorated at right side (facing front). This is a small repair. A qualified person should repair or replace as needed.

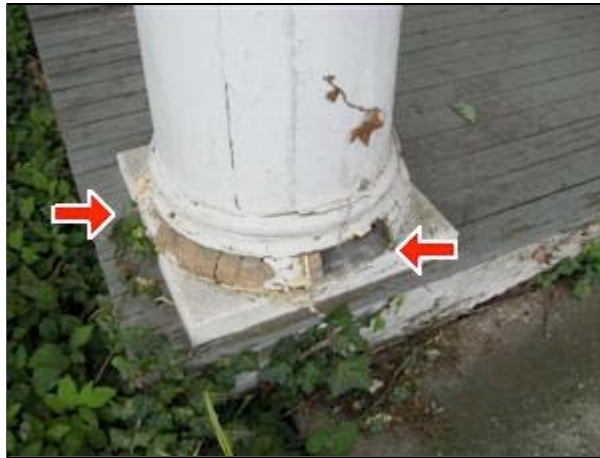
2.3 Picture 1 Front Porch

(1) The support column(s) on covered porch at the left side (facing front) are split or cracked in areas and are deteriorated in areas. A repair or replacement is needed. A qualified contractor should perform the work.

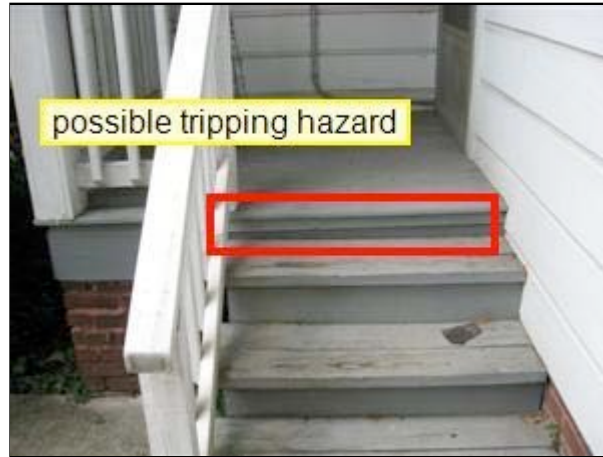
2.3 Picture 2 Rear Porch

(2) The steps on the porch at the rear of home are not uniform in "riser height" and are a tripping hazard. A fall or injury could occur if not corrected. I recommend repair as needed.

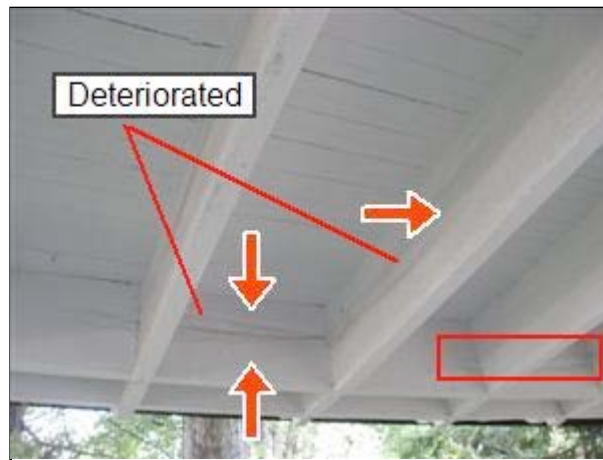
2.3 Picture 3

(3) Some of the rafters of covered porch shows weakening by previous damage from leaks or other. Appears to remain strong to function. FYI

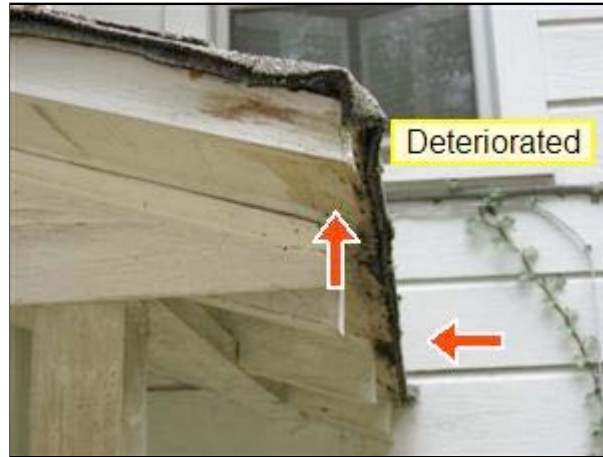
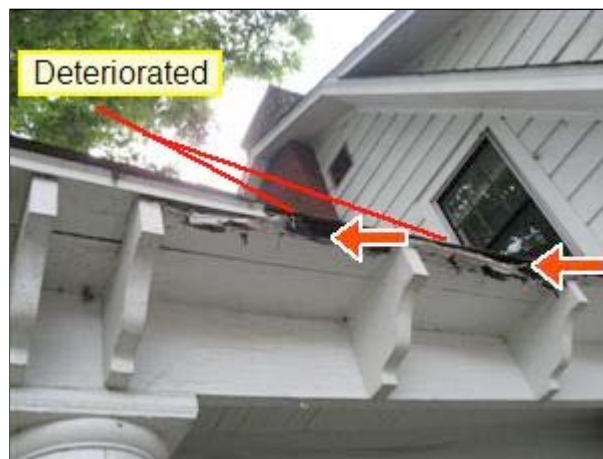
2.5 Picture 1

(1) The eave boards at eave on the gables and various roof edges are deteriorated. Repairs are needed. A qualified contractor should inspect and repair as needed.

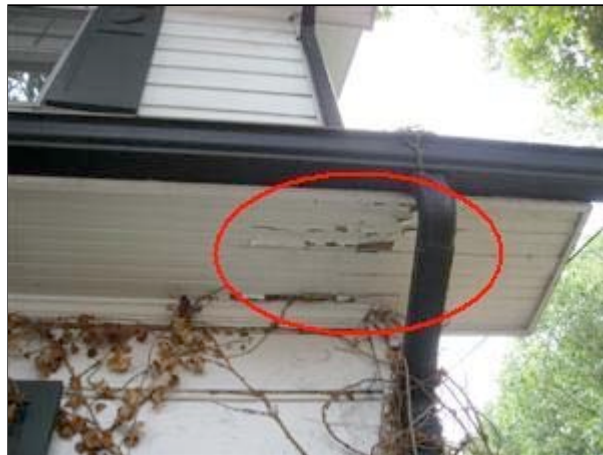
(2) The soffit panel at eave on the front (right of main entry) are weathered and peeling paint. Further deterioration may occur if not repaired. A qualified person should repair or as needed. I am unable to determine if leak exists here or was a result of clogged gutters.

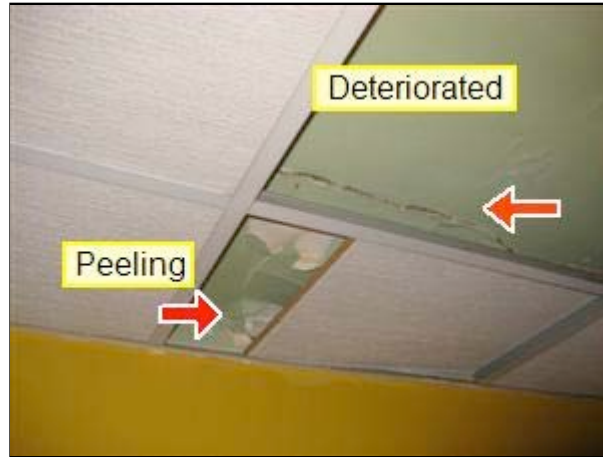
3.0 Picture 1

(1) Plaster ceiling is in need of repair in bathroom. Currently it is covered by drop panels.

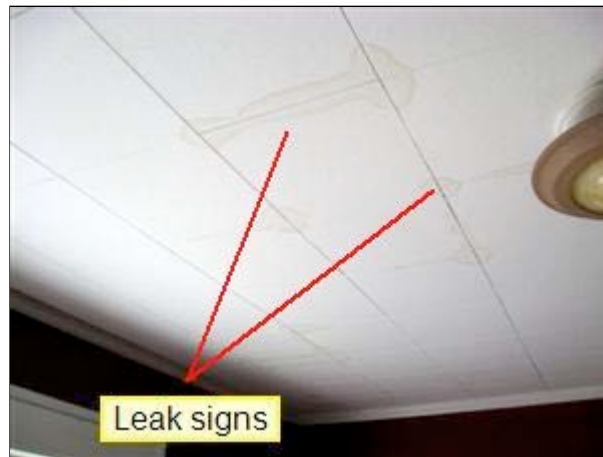
3.0 Picture 2

(2) The Ceiling Tile on the ceiling reveals a water stain indicating a leak did or still exists at the Bedroom. Due to recent dry weather, I am unable to determine if the leak still exists. A qualified contractor should inspect and repair as needed.

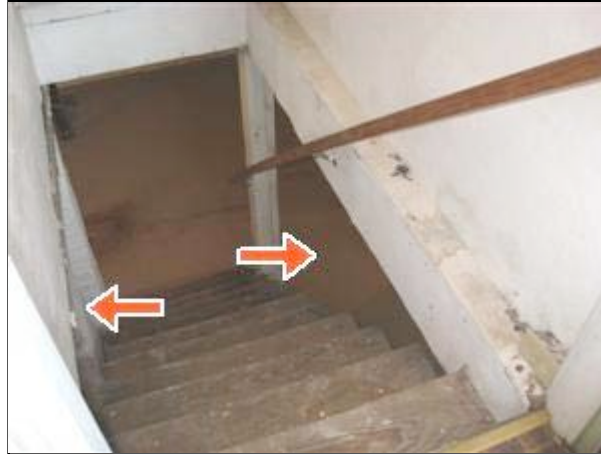
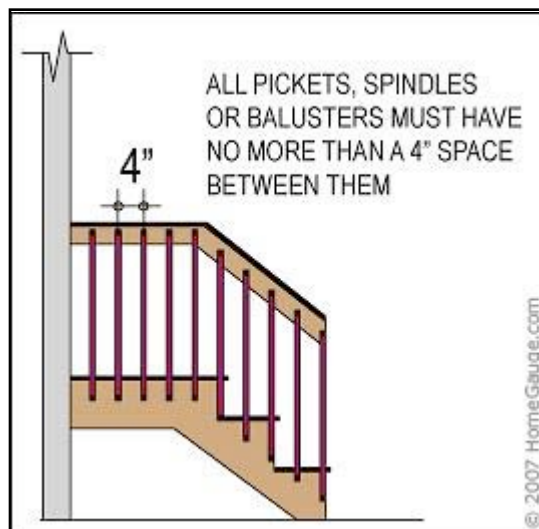
3.3 Picture 1 basement stairs

The hand/guard rail for the stairs to basement are missing balusters (on both sides). A fall or injury could occur if not corrected. A qualified contractor should repair or replace as needed.

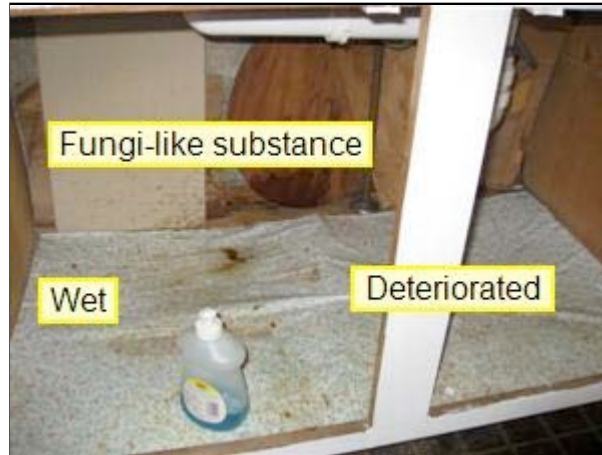
3.4 Picture 1 under kitchen sink

Sink base is damaged under sink at bottom shelf likely from leaking faucet. Recommend repair or replace sink base cabinetry as necessary.

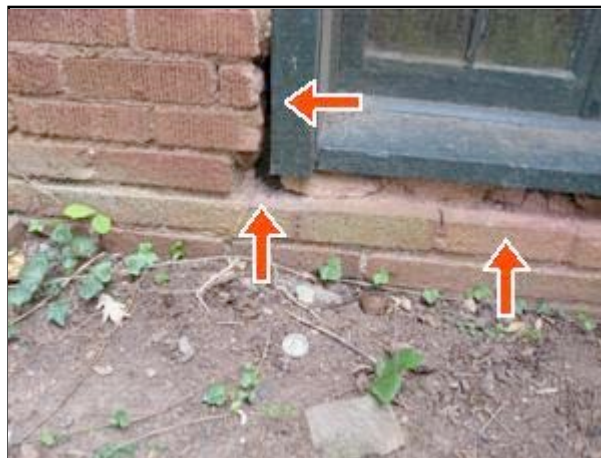
4.0 Picture 1

(1) Brick Foundation wall at the basement entry has missing mortar around windows . Repairs are needed. A skilled masonry contractor should perform the repairs.

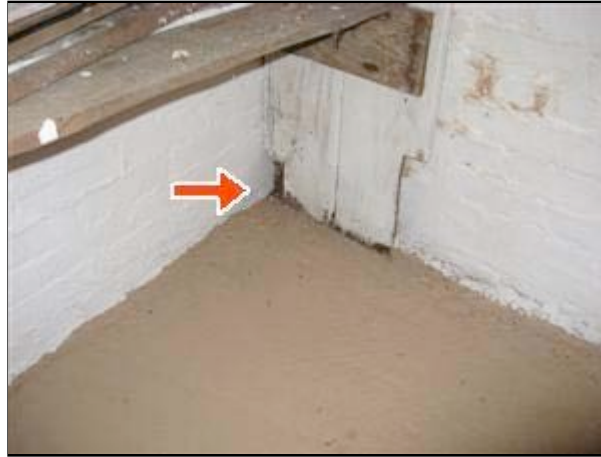
4.0 Picture 2 basement wall

(2) The brick foundation has been coated with a water proof sealer except behind shelving. If water intrusion occurs here, then shelving may need removing in order to coat area properly.

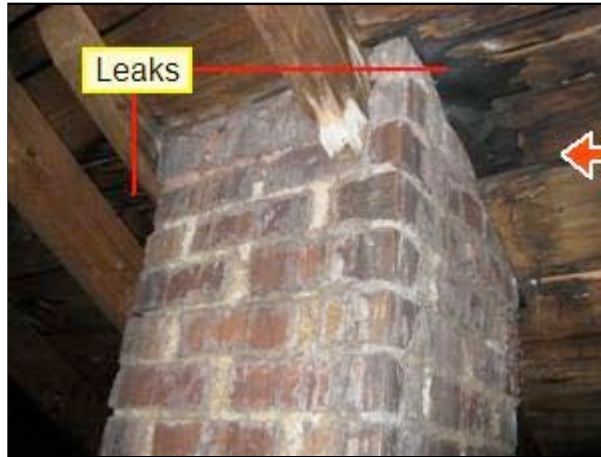
4.5 Picture 1

The common board roofing indicates roof leaks or has leaked around the chimneys. Leaking roofs should be repaired to prevent damage. I recommend a qualified contractor perform the work. (See Roof Coverings comments)

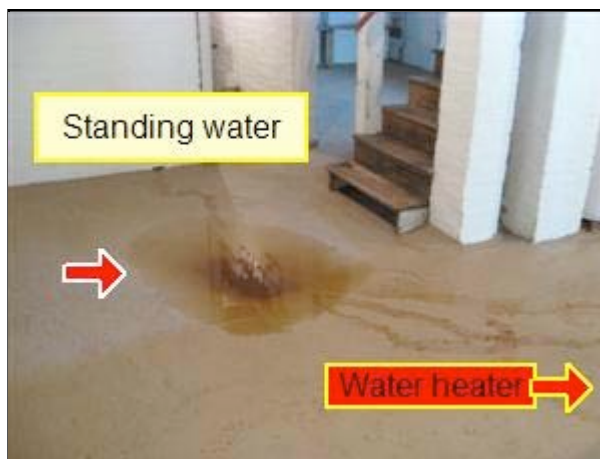
5.0 Picture 1

(1) Upon arriving water was on and spilling onto floor of basement from nearby faucet and water heater. The hvac person who was their at the time of inspection claimed that he turned the water on at the street. I turned off the valve at faucet and water heater. FYI

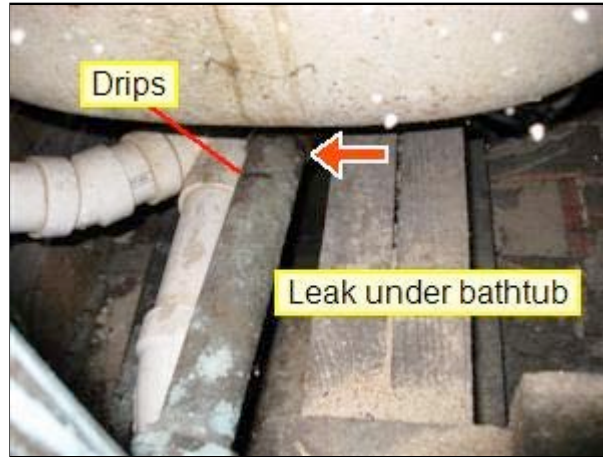
5.0 Picture 2 Upstairs bath

(2) The stop-valve does not work properly at the Hall Bath sink. Repairs are needed. The tub drain drains slowly at main bath. There is a leak under bathtub that can be seen from removing access panel on wall. Repairs are needed. A qualified licensed plumber should repair or correct as needed.

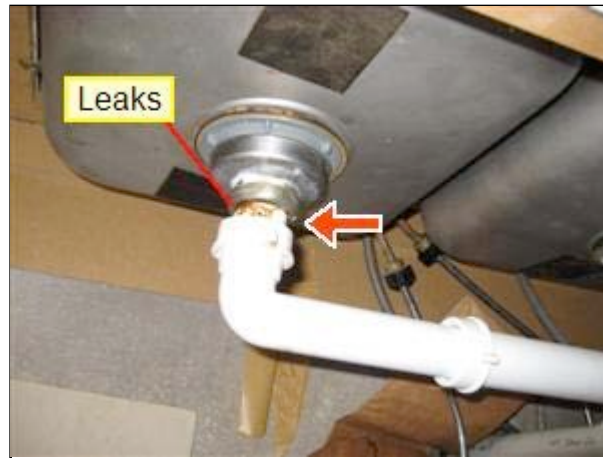
5.0 Picture 3

(3) The basket strainer is leaking at left side and at right side at the Kitchen sink. Repairs are needed. A qualified licensed plumber should repair or correct as needed.

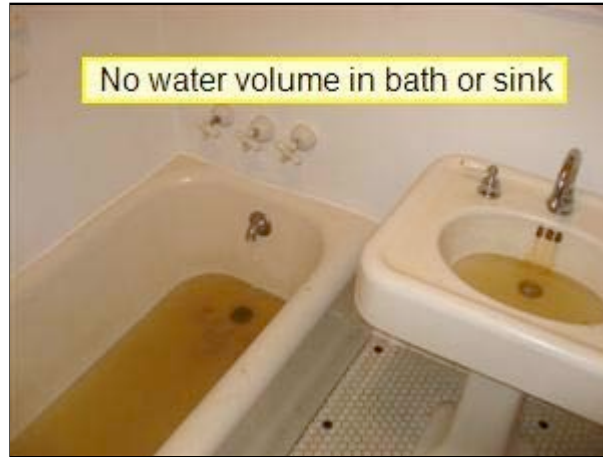
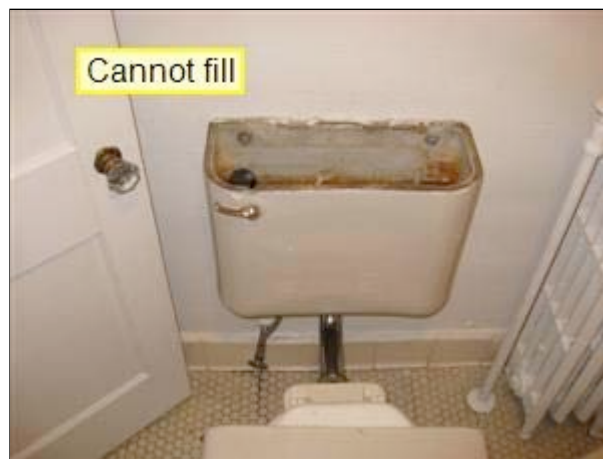
5.1 Picture 1

(1) The lever on faucet leaks at the kitchen sink. Repairs are needed to stop leaking water from further damaging the cabinet bottom or to eliminate moisture that may contribute to fungi growth. I recommend repair as necessary by a qualified person. The spray nozzle is not working properly which could be as a result of no volume or pressure at the kitchen sink. Repairs are needed. A qualified licensed plumber should repair or correct as needed.

(2) The water pressure over-all is poor and would not pass "functional flow." A possible reason for weak volume or pressure could be old galvanized piping that is corroded inside.
NOTE: NO SHOWER FOR BATH

Toilet will not fill with water likely due to clogged piping. I could not inspect the toilet fixture for leaks.

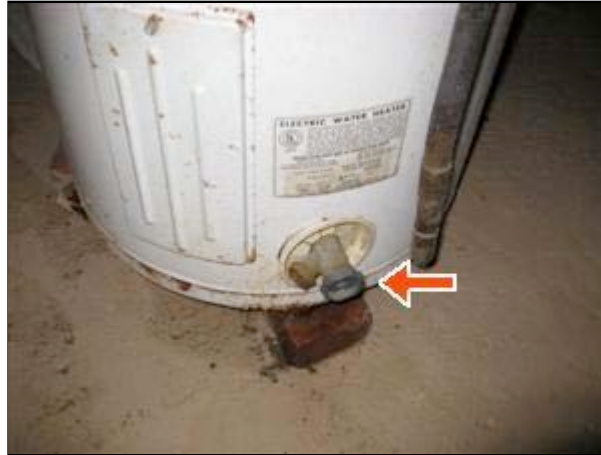
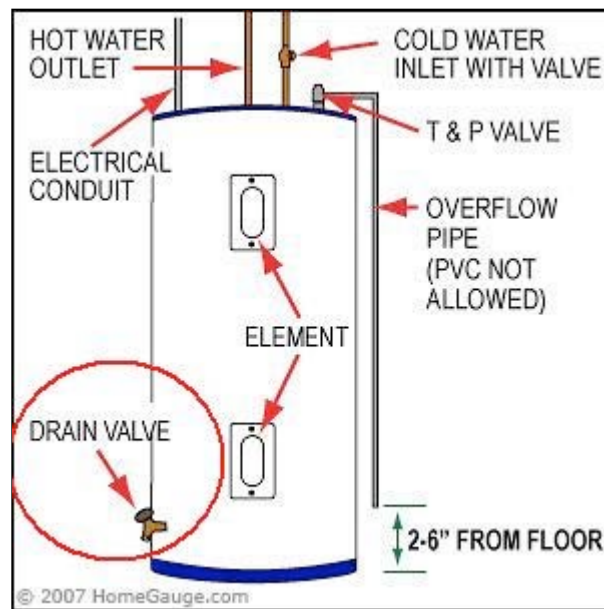
5.2 Picture 1

Water heater was empty and drain open at bottom when I arrived. I closed drain but at the end of inspection, drips were still occurring. Repairs may be needed.

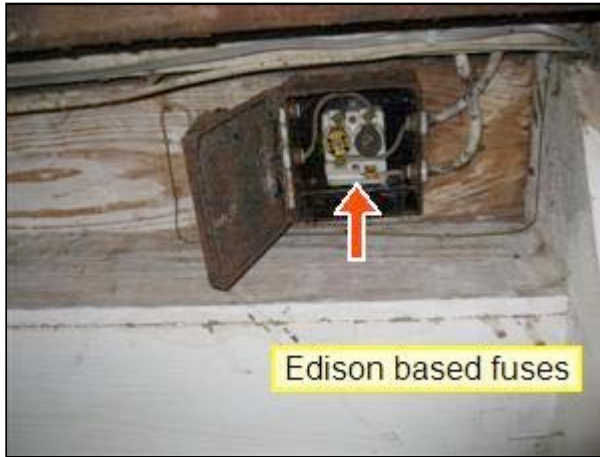
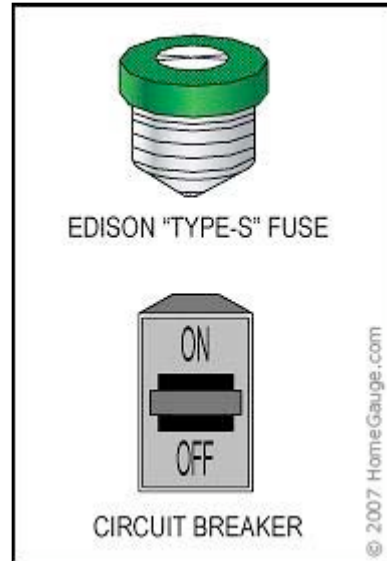
6.2 Picture 1

Branch wire 15 and 20 AMP: Copper
Wiring Methods: Romex, Knob and Tube
Comments:
<input checked="" type="checkbox"/> Problem(s) discovered with Branch Circuits such as doubled wiring at fuse(s), doubled wiring at circuit(s), and edison base fuse(s) under stairs, and any other problems that an electrician may discover while performing repairs need correcting. I recommend a licensed electrician inspect further and correct as needed. |

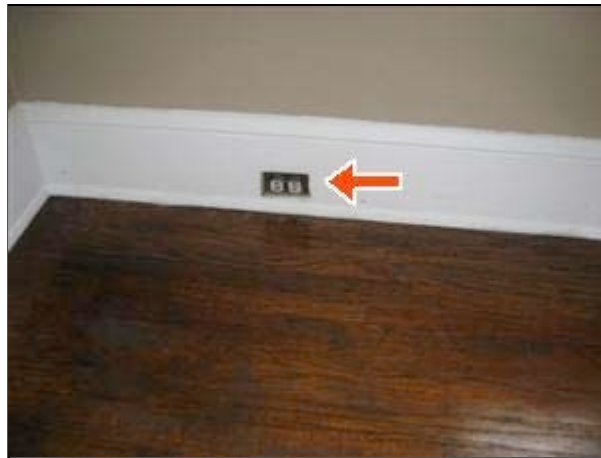
6.3 Picture 1 various rooms

(1) "Two-prong" outlets are missing cover-plates in the dining room and in the living room. This is a safety issue that needs to be corrected. I recommend repair as needed.

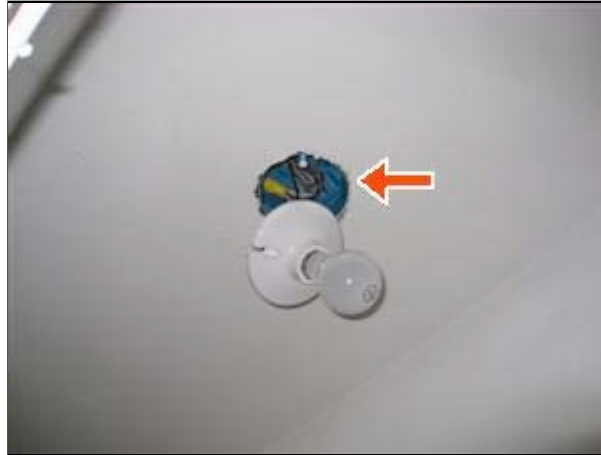
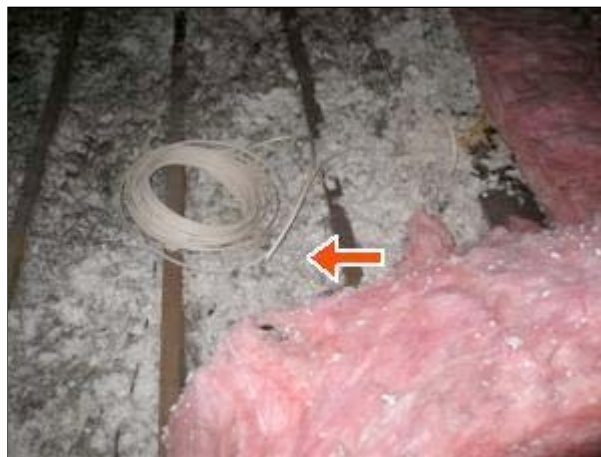
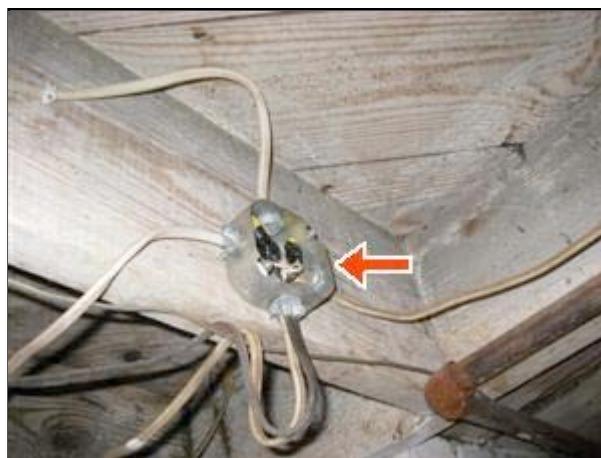
6.3 Picture 2

(2) Loose light fixture needs securing in closet. Loose or unfinished wiring in attic should be corrected to remain safe (Picture 2). One splice box needs a cover-plate in the basement. I recommend repair as needed (Picture 4).

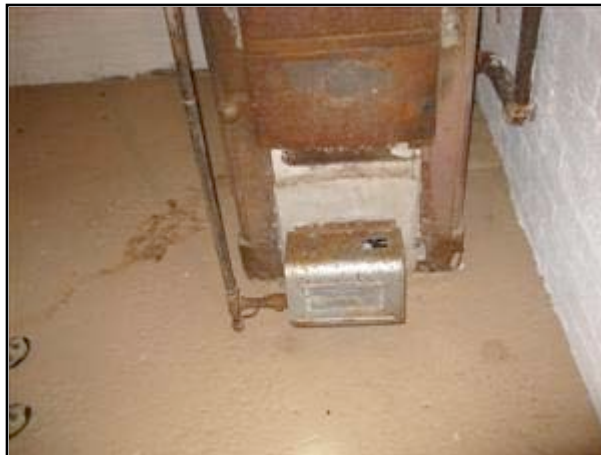
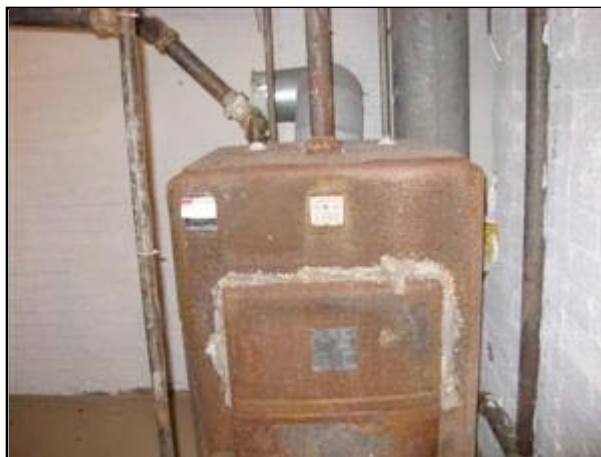
7.0 Picture 1

The gas-fired boiler did not function or is non-operational. A repair or replacement is needed. I recommend further inspection by a licensed HVAC contractor.

Due to the concern for water volume or pressure and because of the old piping that was turned off for an extended period of time, and the fact that the boiler is non-operational, I am concerned of whether or not the radiators will function properly when boiler is repaired. A clogged or failed radiator can be expensive to replace. I strongly recommend that an HVAC person inspect all the radiators when boiler becomes operable. You should obtain a letter from the HVAC company as to the condition of radiators, piping and boiler before you close on home.

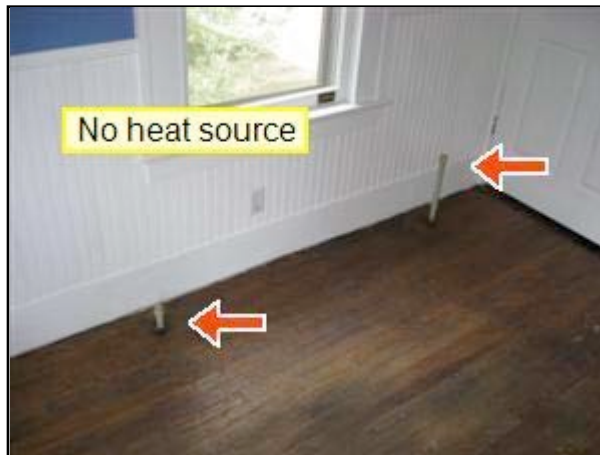
7.4 Picture 1 bedroom

There is no heat source for Bedroom on right (at top of stairs).
