Inspection Report

Property Address:
333 Wild Raspberry Lane
Etowah, NC

HomeBuyers Inspection HBI

Date: 12/19/2007	Time:	Report ID: Sam 1
Property: 333 Wild Raspberry Lane Etowah, NC	Customer: Sample Buyer	Real Estate Professional:

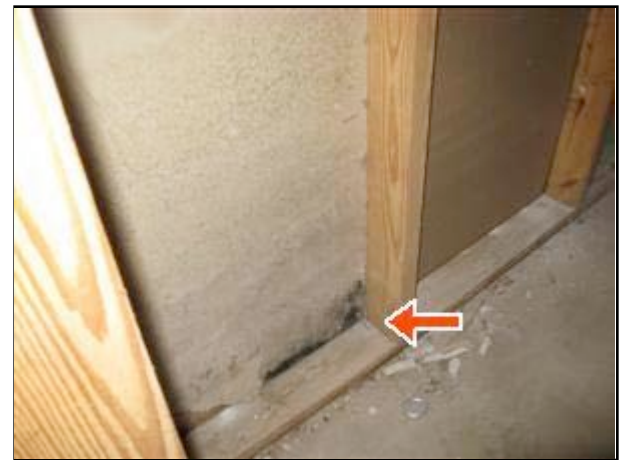
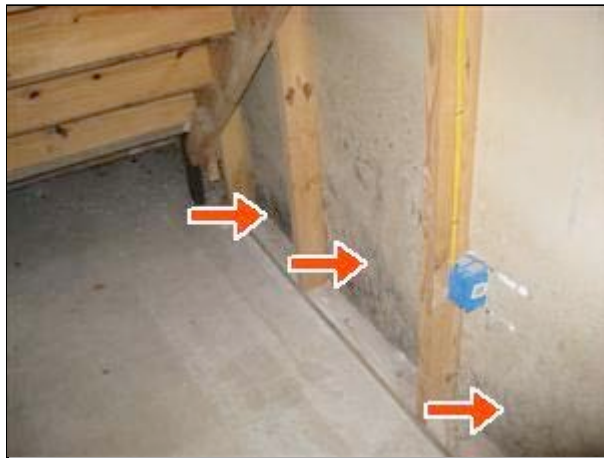
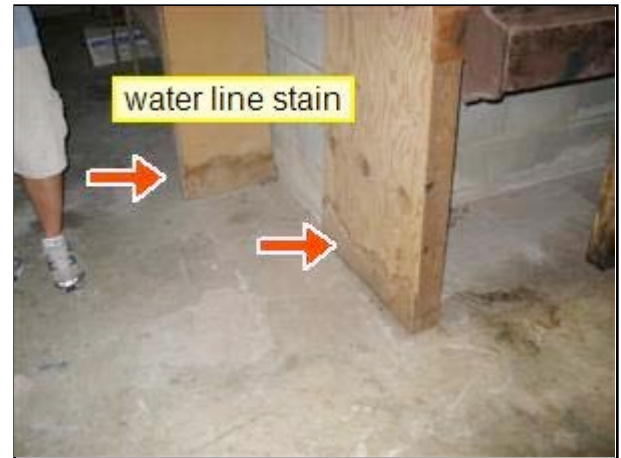
(2) Water signs on cedar wall and trim. Also a mold like substance on carpet at lower level and under stairs. I did not inspect or test for mold and I am unable to determine if water intrusion occurs.

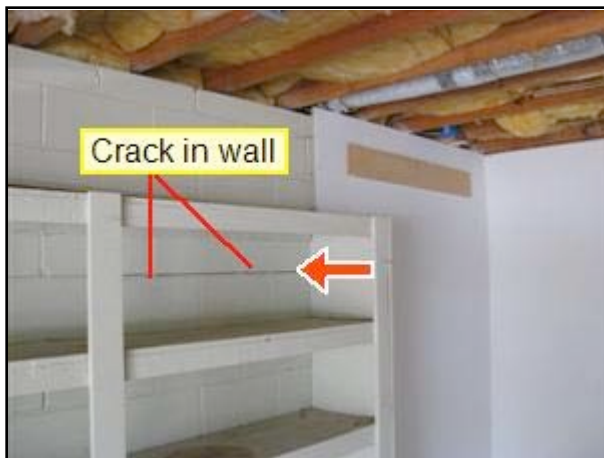
🔍 **1.1** There is a horizontal crack(s) in the foundation wall at the left side (facing front). These cracks do not appear significant to require repairs at this time. This is my opinion and you should seek a second opinion by a qualified person.

- 🔍 There is a horizontal crack(s) in the foundation wall at the left side (facing front). These cracks do not appear significant to require repairs at this time. This is my opinion and you should seek a second opinion by a qualified person.

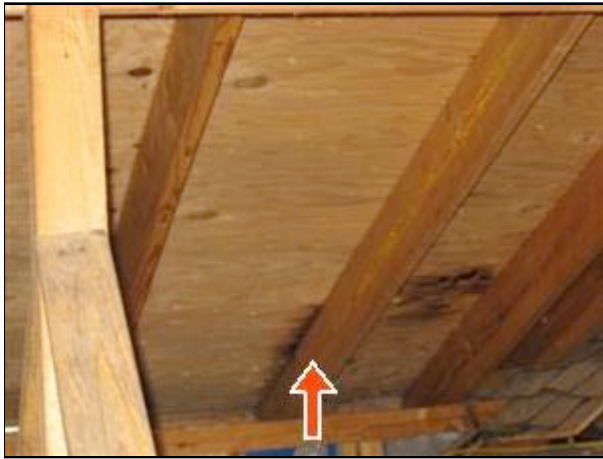
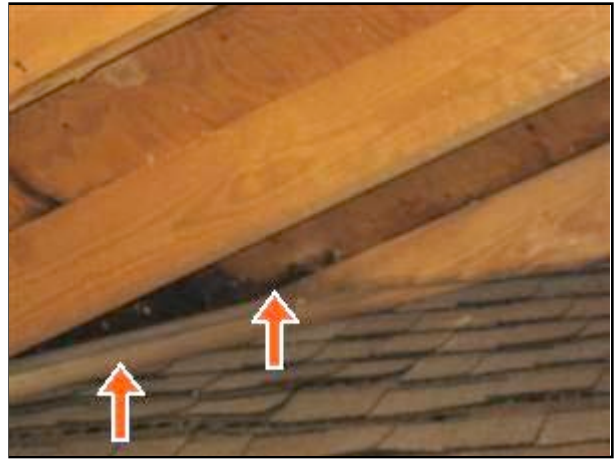
🔍 **1.5** Leak signs in attic perhaps or likely from the **old roof** as this newer roof appears in tact. I am unable to determine if leak exists due to no recent rain.

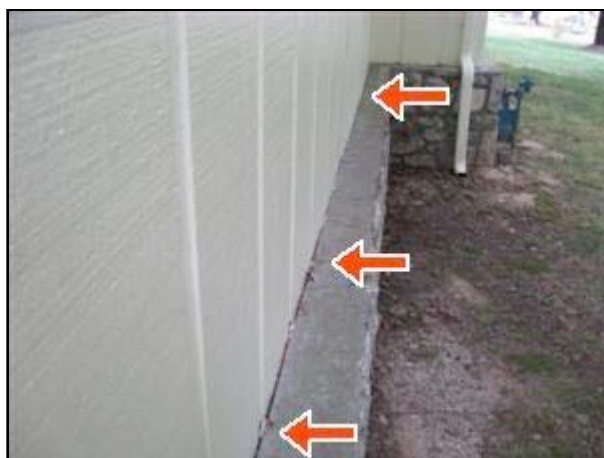
2.0 Picture 1

2.0 Periodical maintenance caulking needed and recommended to keep water from weeping under siding at concrete shelf. FYI

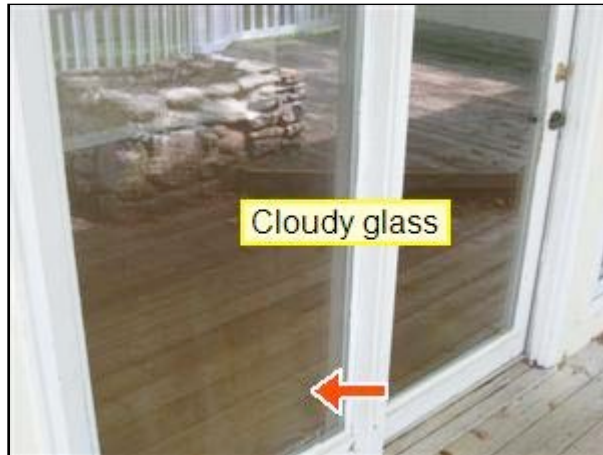
2.1 Picture 1

2.1 Patio doors at rear of home are cloudy or seal is broken. Glass panes that have lost their seal (cloudy) can usually be replaced without replacing the entire unit. A qualified contractor should inspect and

repair as needed.

Patio doors at rear of home are cloudy or seal is broken. Glass panes that have lost their seal (cloudy) can usually be replaced without replacing the entire unit. A qualified contractor should inspect and repair as needed.

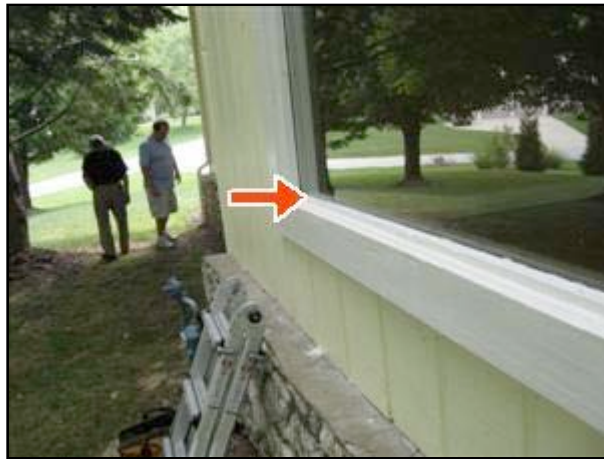
2.2 Picture 1

**2.2** The trim stop for fixed pane is weathered and indicates that water may be getting below trim. I recommend a paintable sealant be applied and paint trim.

The trim stop for fixed pane is weathered and indicates that water may be getting below trim. I recommend a paintable sealant be applied and paint trim.

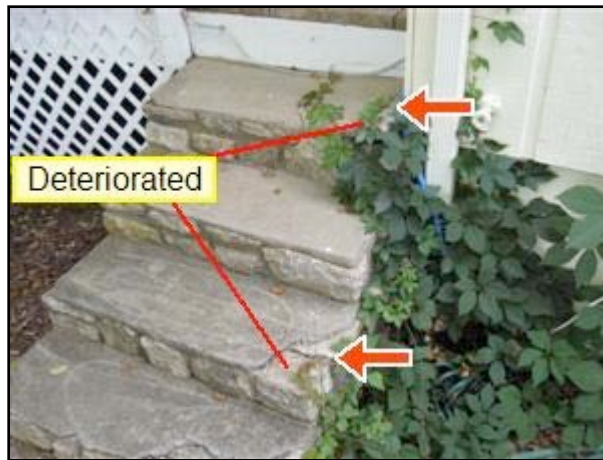
2.3 Picture 1

**2.3** (1) The step tread on steps on the deck at the rear of home are deteriorated. A repair or replacement is needed. A skilled masonry contractor should perform the work.

A handrail may be needed

(1) The step tread on steps on the deck at the rear of home are deteriorated. A repair or replacement is needed. A skilled masonry contractor should perform the work.

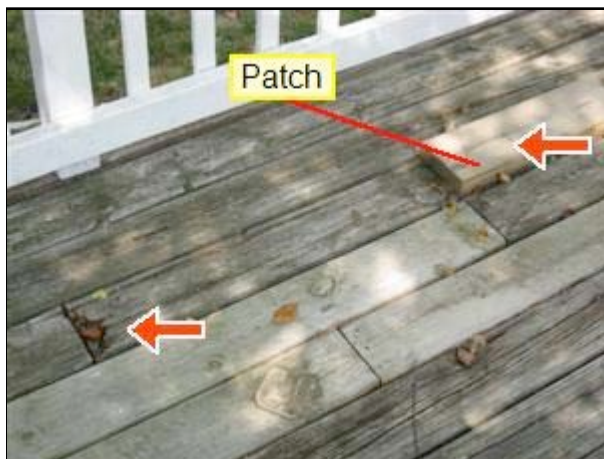
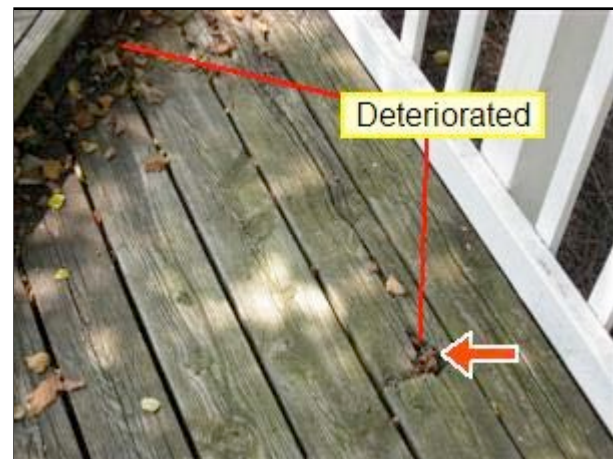
🔨 (2) The 2x6 decking on the deck at the rear of home has several boards that are deteriorated. A general replacement is likely. A qualified contractor should determine whether a repair or replacement is needed.

(2) The 2x6 decking on the deck at the rear of home has several boards that are deteriorated. A general replacement is likely. A qualified contractor should determine whether a repair or replacement is needed.

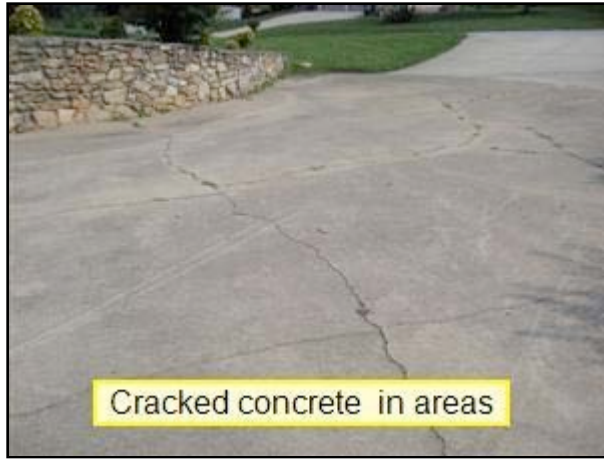
2.4 Picture 1

🔨 **2.4** The concrete drive at the front of home is pitted in areas and has settlement cracks. Further deterioration can occur if not repaired. A qualified contractor should inspect and repair as needed.

The concrete drive at the front of home is pitted in areas and has settlement cracks. Further deterioration can occur if not repaired. A qualified contractor should inspect and repair as needed.

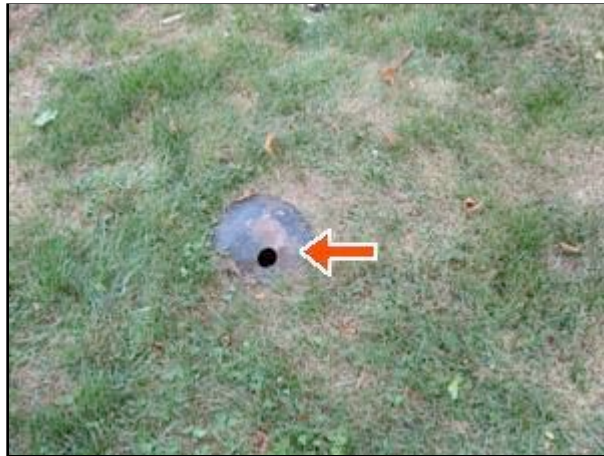
2.6 Picture 1

🔍 **2.6** (1) Old propane tank in ground and is discontinued. I did not determine if gas remains in discontinued tank? I recommend further investigation by a qualified person.

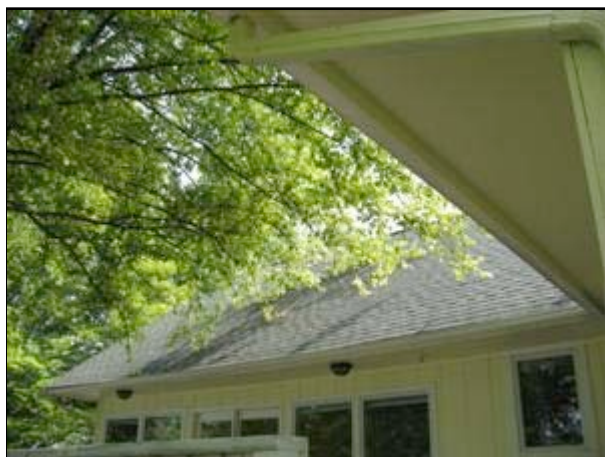
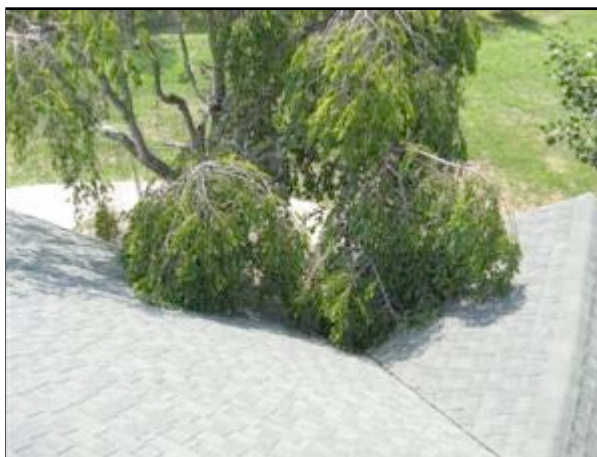
**3.0** (1) The tree limbs that are in contact with roof or hanging near roof should be trimmed.

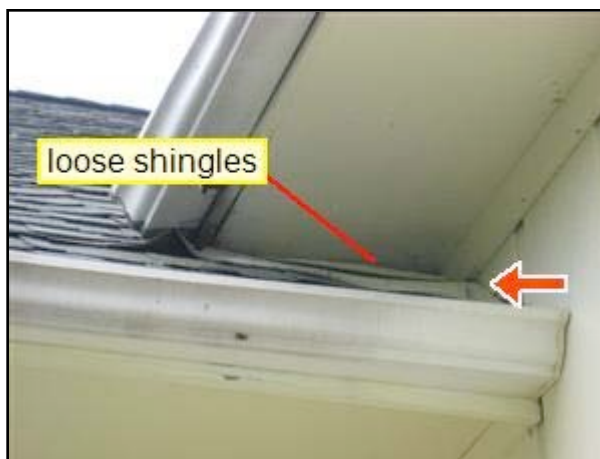
3.0 Picture 3

(2) Shingles loose under eave at front of home, needs adhesive.

(2) Shingles loose under eave at front of home, needs adhesive.

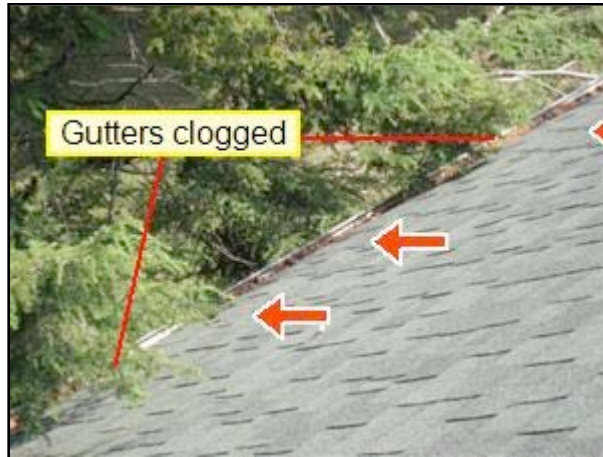
3.3 Picture 1

**3.3** The gutter needs cleaning of debris at the virtually all areas where gutters are installed. Gutters that

drain poorly or clogged can lead to many costly problems such as deterioration of fascia, soffit or roof edge. It can also cause gutters to pull loose and lead to possible water intrusion. A qualified person should repair or replace as needed.

The gutter needs cleaning of debris at the virtually all areas where gutters are installed. Gutters that drain poorly or clogged can lead to many costly problems such as deterioration of fascia, soffit or roof edge. It can also cause gutters to pull loose and lead to possible water intrusion. A qualified person should repair or replace as needed.

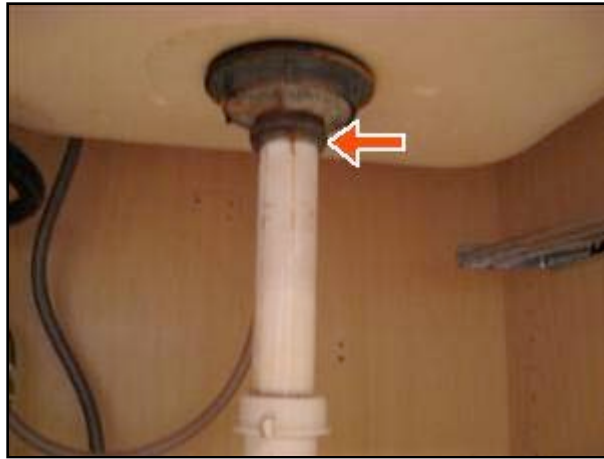
4.0 Picture 1 Right sink basin

**4.0** (1) The basket strainer had leaked and corrected itself for the time being at the Kitchen sink. Repairs are needed. A qualified person should repair as necessary.

(1) The basket strainer had leaked and corrected itself for the time being at the Kitchen sink. Repairs are needed. A qualified person should repair as necessary.

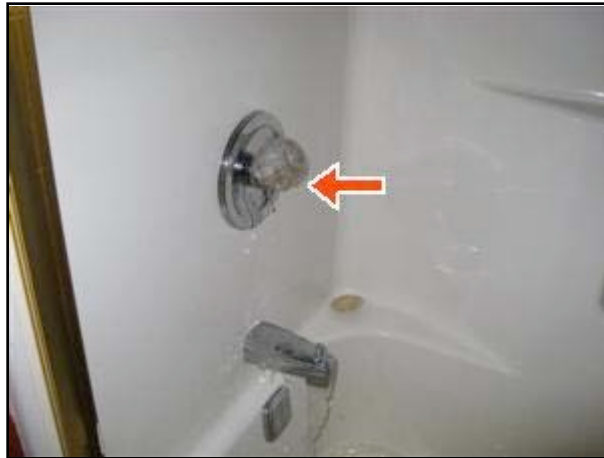
4.1 Picture 1 hall bath

🔧 4.1 (1) The control knob leaks at the hall bath. Repairs are needed. A qualified licensed plumber should repair or correct as needed.

(1) The control knob leaks at the hall bath. Repairs are needed. A qualified licensed plumber should repair or correct as needed.
-

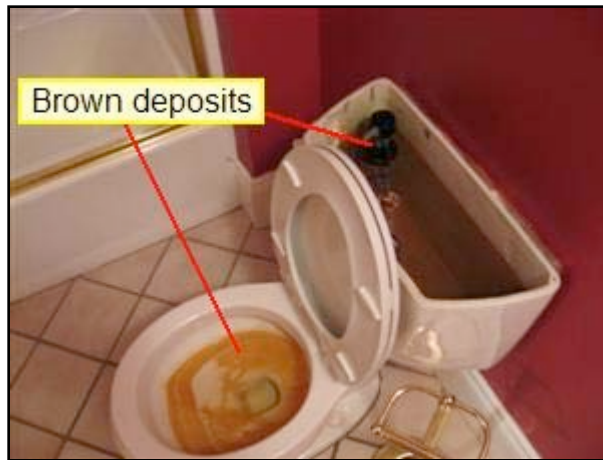
4.1 Picture 2

🔍 (2) Brown deposits are on the plumbing fixtures which indicates a filter may be needed. Filter in place and appears dirty but I am unable to determine if you need a different or additional filter. I did not test water for bacteria or other. I recommend contacting a water filtration company.

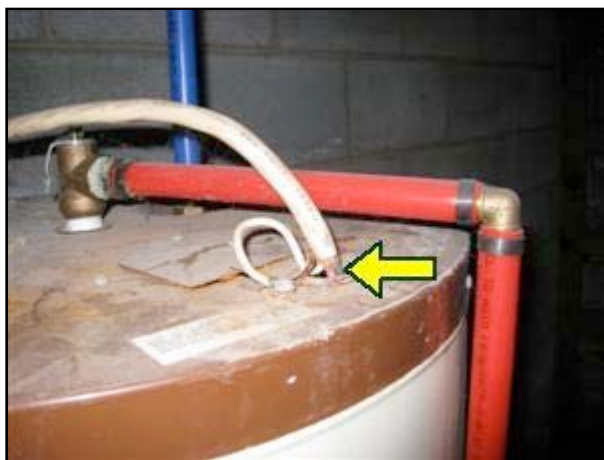
🔧 **4.2** The wiring for the water heater missing romex connector. Electrical issues are considered a hazard until repaired. I recommend a licensed electrician correct as necessary.

The wiring for the water heater missing romex connector. Electrical issues are considered a hazard until repaired. I recommend a licensed electrician correct as necessary.

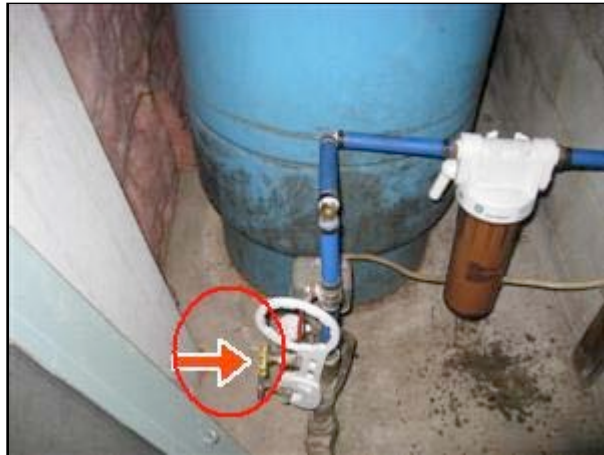
4.3 Picture 1 In basement

4.3 The main shut off is the yellow knob located in the basement at the pressure tank. This is for your information.

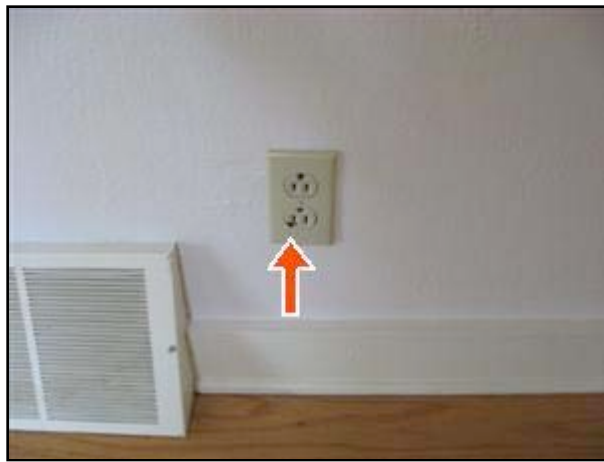
5.3 Picture 1

**5.3 (1)** The wall switch is broken (unsafe) at the upstairs closet for air handler. At least two outlets are broken at LR and entry way. Electrical issues are considered a hazard until repaired. A qualified licensed electrician should perform repairs that involve wiring.

(1) The wall switch is broken (unsafe) at the upstairs closet for air handler. At least two outlets are broken at LR and entry way. Electrical issues are considered a hazard until repaired. A qualified licensed electrician should perform repairs that involve wiring.

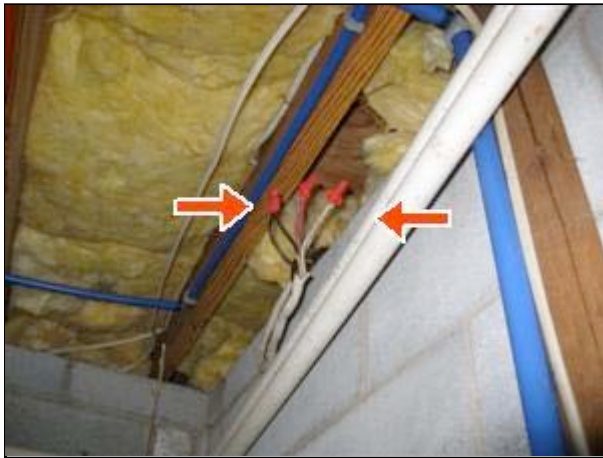
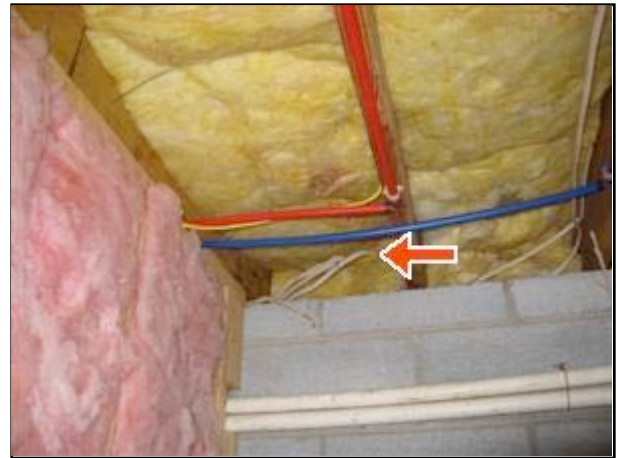
🔍 (2) Several loose wire ends needs placing inside a box with a cover-plate in the basement at the pressure tank of well. I recommend repair as needed.

(2) Several loose wire ends needs placing inside a box with a cover-plate in the basement at the pressure tank of well. I recommend repair as needed.

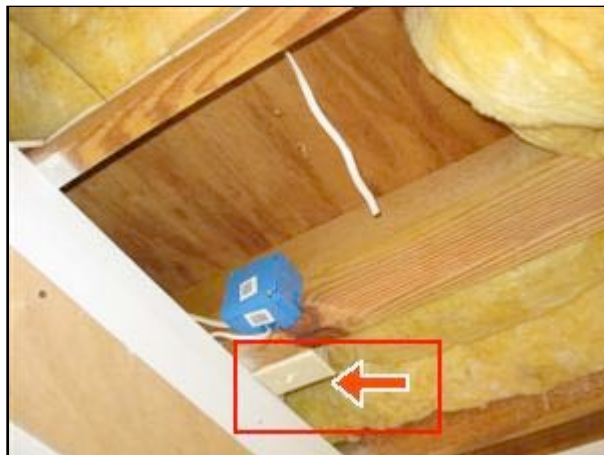
5.3 Picture 4

🔍 (3) Wall switch on ceiling in Garage, purpose unknown

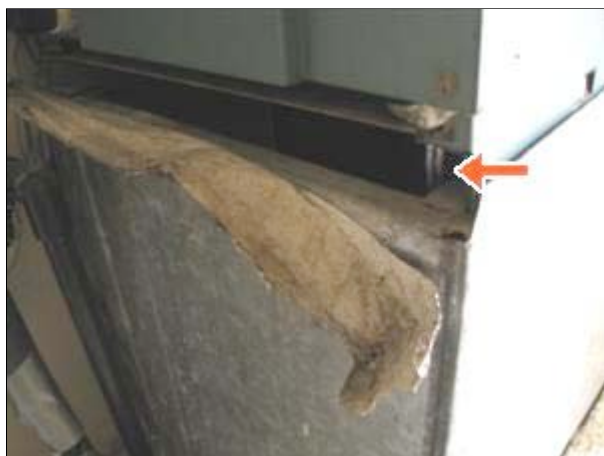
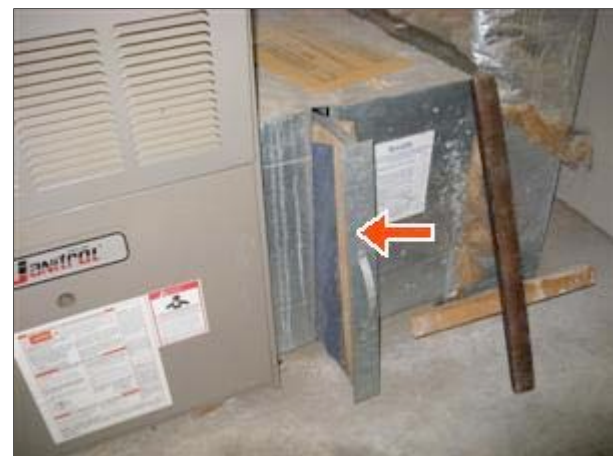
**6.3** (1) The washable filter is collapsed and needs replacing at upstairs. The filter needs replacing with a rigid frame to prevent filter from falling out of alignment. (Picture 1) The filter in basement (Picture 2) needs replacement and in crawlspace which is difficult to access due to the crawlspace (Picture 3). A qualified person should repair or replace as needed

(1) The washable filter is collapsed and needs replacing at upstairs. The filter needs replacing with a rigid frame to prevent filter from falling out of alignment. (Picture 1) The filter in basement (Picture 2) needs replacement and in crawlspace which is difficult to access due to the crawlspace (Picture 3). A

qualified person should repair or replace as needed

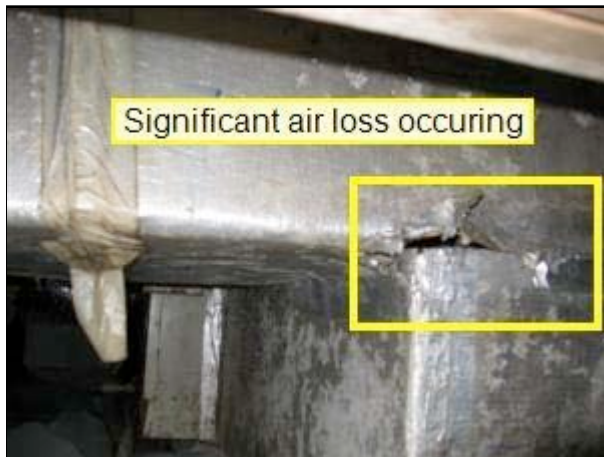
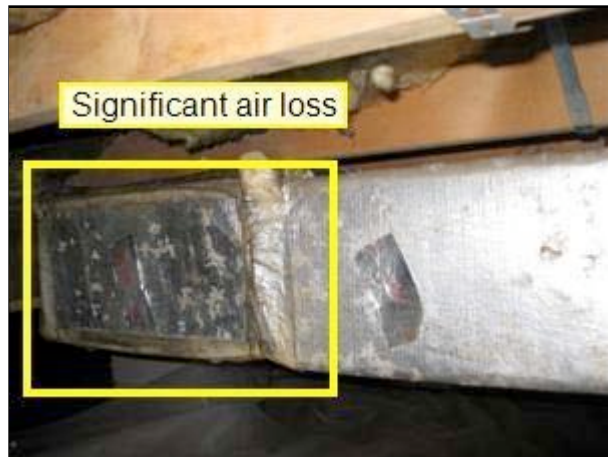
🔦 (2) The supply duct pipe or main plenum is failing in the crawlspace. Energy loss is occurring in crawlspace and immediate correction is needed. A licensed HVAC contractor should service or repair unit.

(2) The supply duct pipe or main plenum is failing in the crawlspace. Energy loss is occurring in crawlspace and immediate correction is needed. A licensed HVAC contractor should service or repair unit.

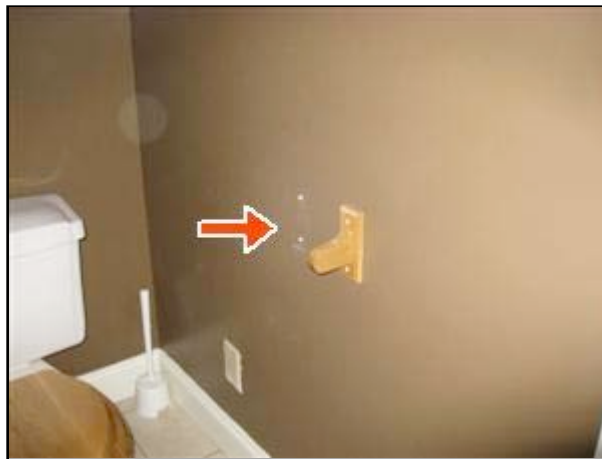
8.1 Picture 1

**8.1** The tissue holder on the wall is damaged at the master bath. I recommend repair as necessary.

The tissue holder on the wall is damaged at the master bath. I recommend repair as necessary.

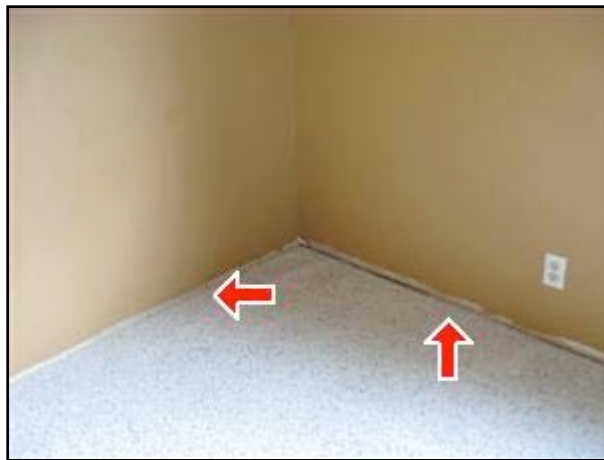
8.2 Picture 1

**8.2** (1) The Baseboard is missing at the upstairs (right of hall bath). Repairs are needed. A qualified contractor should inspect and repair as needed.

(1) The Baseboard is missing at the upstairs (right of hall bath). Repairs are needed. A qualified contractor should inspect and repair as needed.
-

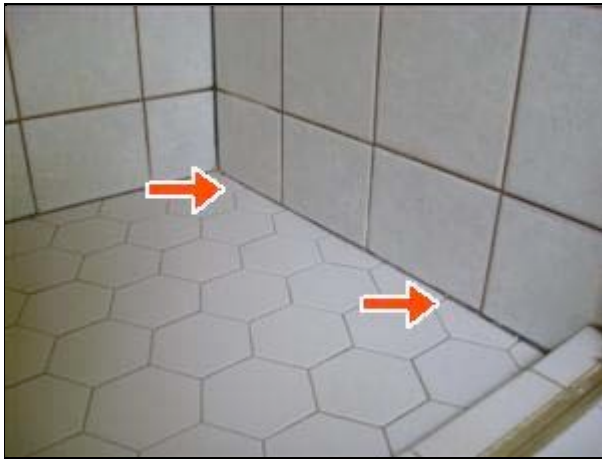
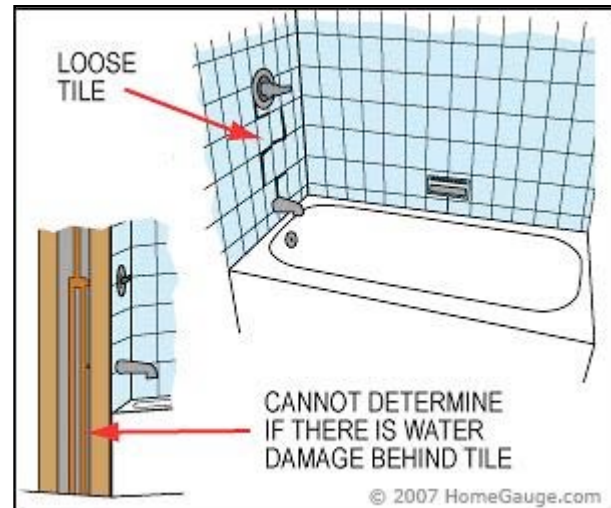
🔧 (2) Tile at shower pan and wall surround are loose and missing mortar or grout and sealer at the upstairs bath. Repairs are needed to prevent water damage to shower/bath. A qualified person should repair or replace as needed.

(2) Tile at shower pan and wall surround are loose and missing mortar or grout and sealer at the upstairs bath. Repairs are needed to prevent water damage to shower/bath. A qualified person should repair or replace as needed.

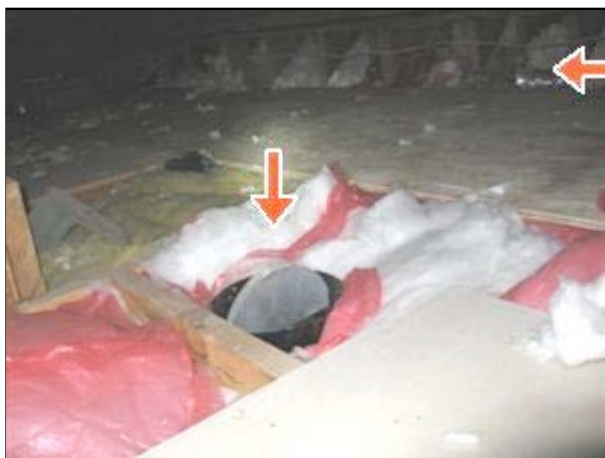
9.4 The Exhaust fan does not vent to outside at the hall bath and master bath. Vent pipes should terminate outside and not in the attic. Many homes have their vent pipe poised at the roof vent such as yours. It is up to you to determine whether or not this is a concern or needs further consideration from a general contractor. A qualified contractor should inspect and repair as needed.

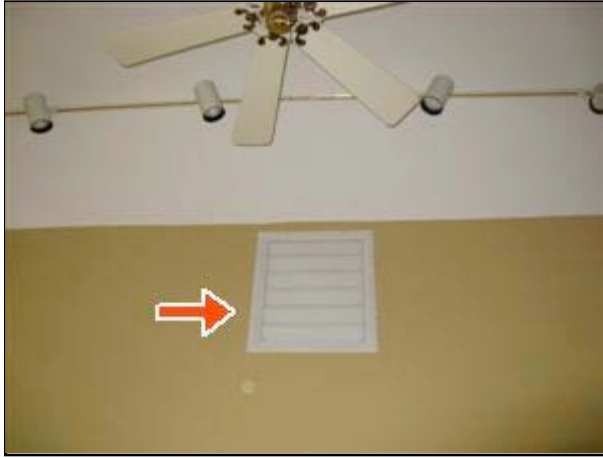
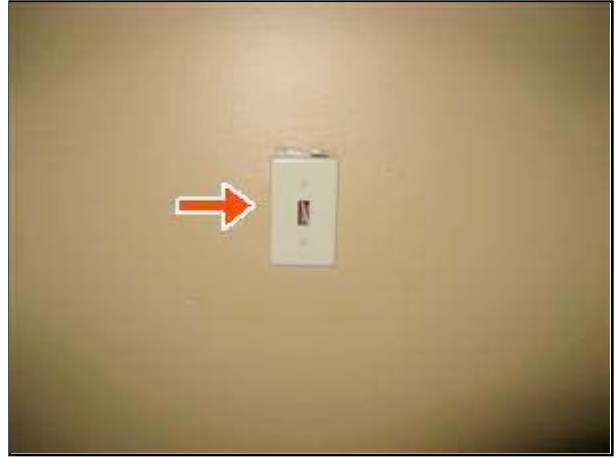
**9.5** Wall switch for room fan in wall has been removed. It is inoperable.
