Inspection Report

Property Address:
333 Wild Raspberry Lane
Etowah, NC

HomeBuyers Inspection HBI

Date: 12/19/2007	Time:	Report ID: Sam 1
Property: 333 Wild Raspberry Lane Etowah, NC	Customer: Sample Buyer	Real Estate Professional:

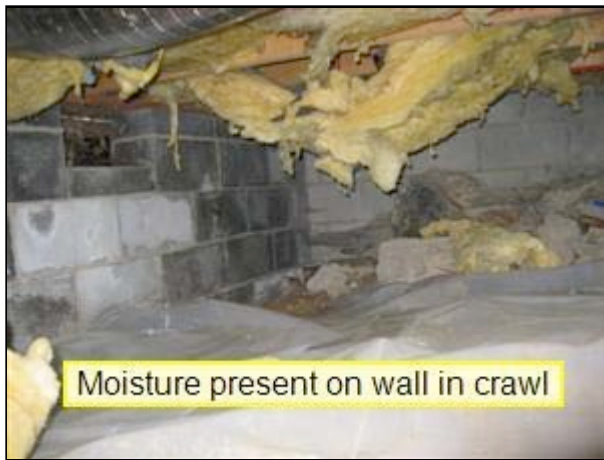
1.0 Picture 5 crawlspace under kitchen

(3) Visible signs of water intrusion in the crawlspace (along front of home) are present from dampness along the block wall. I am unable to determine the extent of intrusion or how often it occurs. Cross ventilation may help as the crawls has no ventilation. I recommend further investigation or correction by a qualified licensed contractor or water infiltration specialist. Refer to the diagram as a guide if a drainage system is needed.

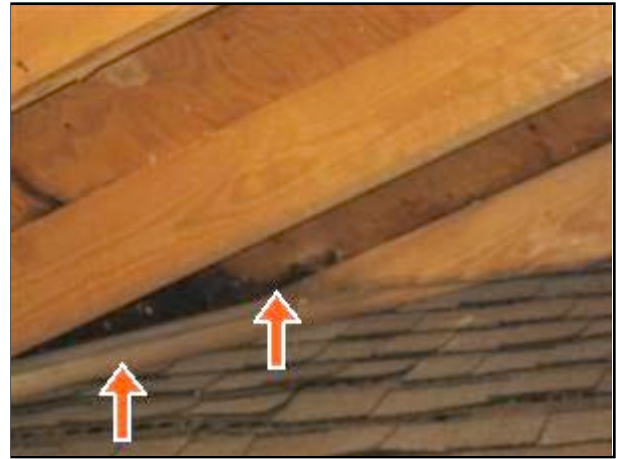
1.5 Picture 1

🔍 **1.5** Leak signs in attic perhaps or likely from the **old roof** as this newer roof appears in tact. I am unable to determine if leak exists due to no recent rain.

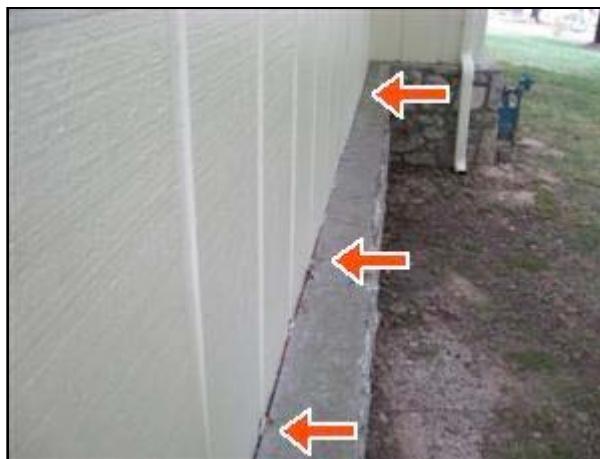
2.0 Picture 1

2.0 Periodical maintenance caulking needed and recommended to keep water from weeping under siding at concrete shelf. FYI

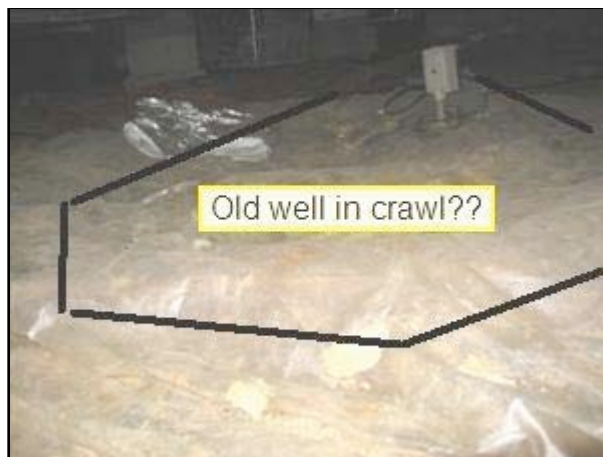
2.6 Picture 2 in crawlspace under new addition

🔍 (2) There is an odd configuration in ground under addition in crawlspace. This may be an old well? I am unable to determine. I recommend a qualified well drilling company or plumber investigate further to determine if any further action is needed to correct.

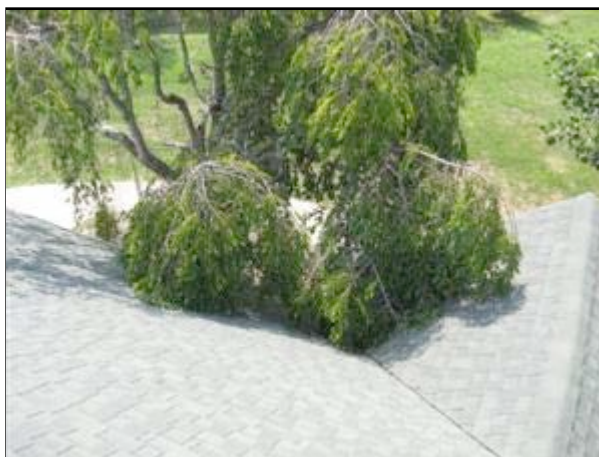
3.0 Picture 1 Rear of home

**3.0 (1)** The tree limbs that are in contact with roof or hanging near roof should be trimmed.

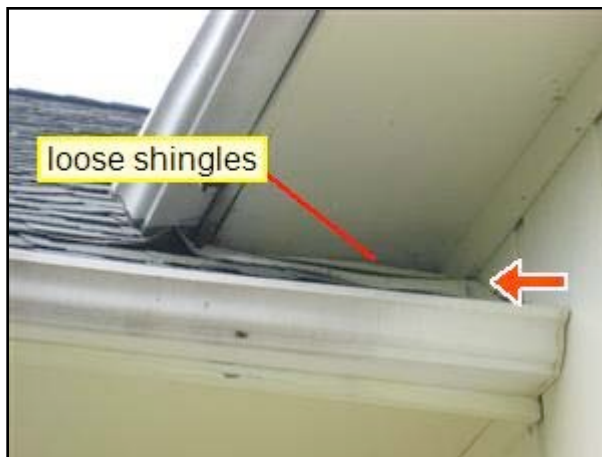
3.0 Picture 3

(2) Shingles loose under eave at front of home, needs adhesive.

(2) Shingles loose under eave at front of home, needs adhesive.

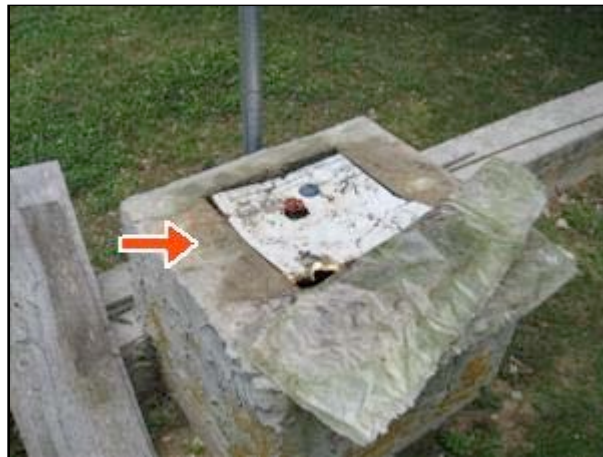
4.1 Picture 3 Well head

🔧 (3) I recommend the well head lid be insulated better before winter. FYI

(3) I recommend the well head lid be insulated better before winter. FYI

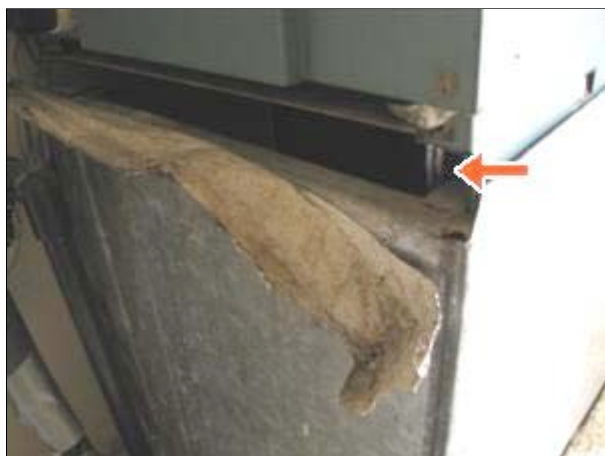
6.3 Picture 1

**6.3 (1)** The washable filter is collapsed and needs replacing at upstairs. The filter needs replacing with a rigid frame to prevent filter from falling out of alignment. (Picture 1) The filter in basement (Picture 2) needs replacement and in crawlspace which is difficult to access due to the crawlspace (Picture 3). A qualified person should repair or replace as needed

(1) The washable filter is collapsed and needs replacing at upstairs. The filter needs replacing with a rigid frame to prevent filter from falling out of alignment. (Picture 1) The filter in basement (Picture 2) needs replacement and in crawlspace which is difficult to access due to the crawlspace (Picture 3). A

qualified person should repair or replace as needed

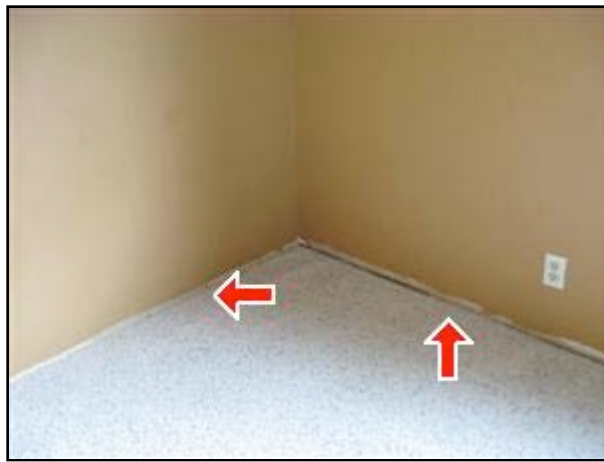
8.2 Picture 1

**8.2** (1) The Baseboard is missing at the upstairs (right of hall bath). Repairs are needed. A qualified contractor should inspect and repair as needed.

(1) The Baseboard is missing at the upstairs (right of hall bath). Repairs are needed. A qualified contractor should inspect and repair as needed.
-
